# Grain Dust Explosion Prevention

# UNITED STATES GRAIN CORPORATION

In Co-operation with the Bureau of Chemistry

NEW YORK June 1920

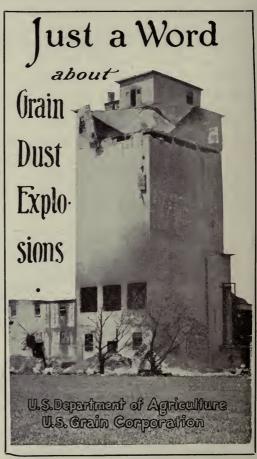
Fig. 7.—Upper portion of this plant destroyed by dust explosion. From cover-page of pamphlet used in educational campaign.

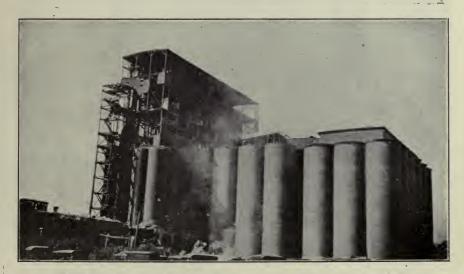
Explosion originated in basement.

Fig. 13.—Explosion traveled from basement through man-lift tower to "texas" or top of elevator.

tially wrecked, the property loss being estimated at \$650,000. This explosion was not confined to any one portion of the elevator, but propagated to all sections of the workhouse.

The evidence at hand indicates that the explosion originated in the basement, in the vicinity of one of the receiving legs, where workmen were cleaning up the plant. Great difficulty was encountered in determining the exact cause of the explosion, owing to the fact that all the evidence required to establish it had been destroyed on account of the force of the blast. Judging from the violence of the explosion, the dust in this plant must have been very inflammable.

The evidence secured from one of the workmen indicated that the source of ignition may have come from an electrical short circuit. This workman stated that he heard a sharp cracking noise shortly before the explosion, and thought that he had seen blue flashes of flame traveling along the electric light wires. The short circuit may have been caused by defective extension cords or the breaking of an unprotected lamp bulb in the dusty atmosphere present. Workmen in the basement were known to have been using extension cords at the time of the explosion, and it is possible that ignition came from such a source.

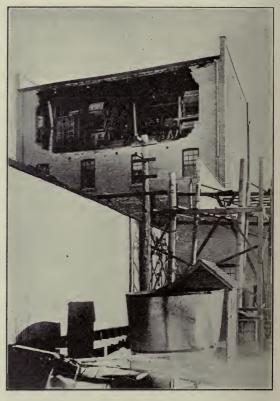
The explosion, caused by the striking of a match in a flour bin, propagated up the stairway and through other openings to the next floor above where a secondary explosion did extensive damage. The brick wall at one side of the mill was blown out and the warehouse was damaged. As the mill was quite clean, very little fire occurred.

Fig. 16.—Explosion blew out wall of upper floor after propagating from floor below.
